HYDROLOGICAL IMPACTS ON THE MAINTENANCE AND REHABILITATION OF RURAL ROAD NETWORKS IN KENYA: THE CASE OF CHEPTIRET-KESSES ROAD, UASIN-GISHU DISTRICT

J.K. M'Ndegwa

Department of Civil and Structural Engineering, Moi University, Kenya

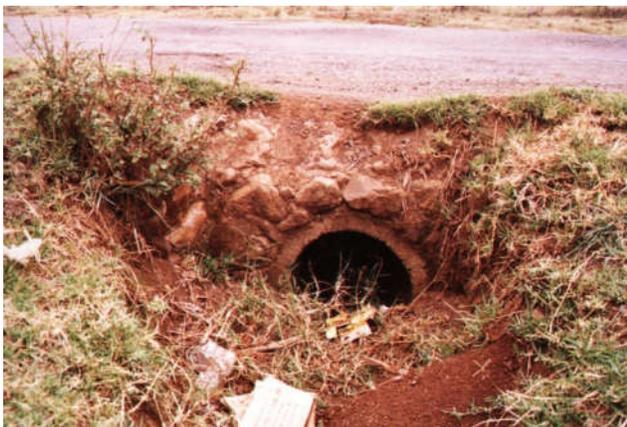
The damage it caused to the road was also assessed accordingly. The key defects observed included silting up of side ditches and culverts as shown in plate 1. Due to silting up of those structures, the surface run-off could not flow directly to natural drainage systems as designed but flowed across on the road surface to those drainage systems. As it flowed across, the water therefore seeped through the cracked road surface into the pavement and to the subgrade causing instability of the road structure. Technically the water that percolates through road pavement to the subgrade increases moisture content of the road structure above that used during construction. This increase may particularly affect the subgrade adversely by reducing its ability to take the traffic loading distributed over it by the overlying pavement layers. This can result in disruption of the whole road structure.

Plate 1. Silted up culvert entrance along Kesses-Cheptiret Road

- Install culverts of adequate size and lay them at suitable gradient.
- Provide a cambered and impervious road surface.
- Raise road embankment so that the road formation level is much greater than 600mm above the highest underground water table level..
- Repair damaged structures and institute regular maintenance programme.

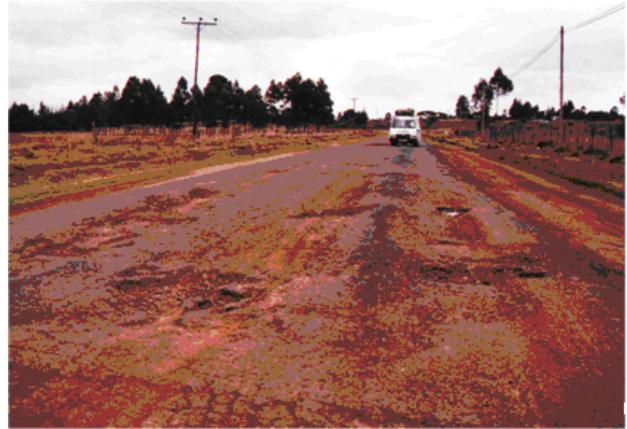
Pavement weakening could have been also caused by water reaching the subgrade through capillarity from high water table. This too could result in subgrade weakening and consequently make it overstressed, due to its reduced ability to take the intended traffic loading. The subgrade failure almost always gave rise to cracking and deterioration of riding quality of the road surface. The ingress of water into the pavement could have resulted in softening of roadbase leading to deep rutting and road surface cracking. That occurred despite the traffic using the road not being very heavy. Consequently the surfacing deteriorated further into potholes shown in plate 2.

Plate 2: Potholed section of Kesses-Cheptiret Road

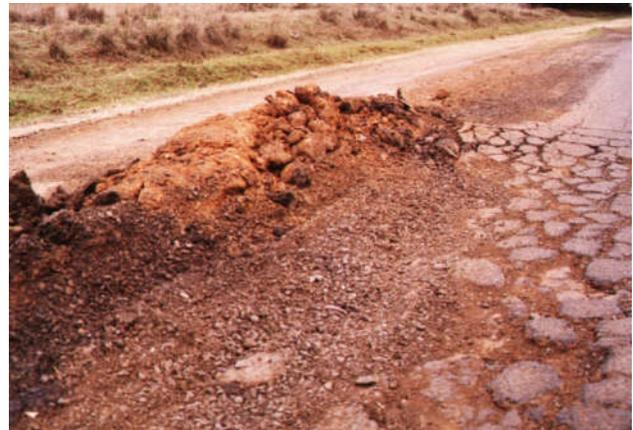
The seepage of water from high ground to the subgrade causes softening of the subgrade and ultimately reduces its bearing capacity. With reduced bearing capacity, the subgrade may get overstressed when loaded and led to pavement failure. The failure may be in form of localized settlement of the pavement and caused extensive cracking of the road surface. It could also lead to pavement disintegration as illustrated in plate 3.

Plate 3: Completely failed road base along Kesses – Cheptiret Road

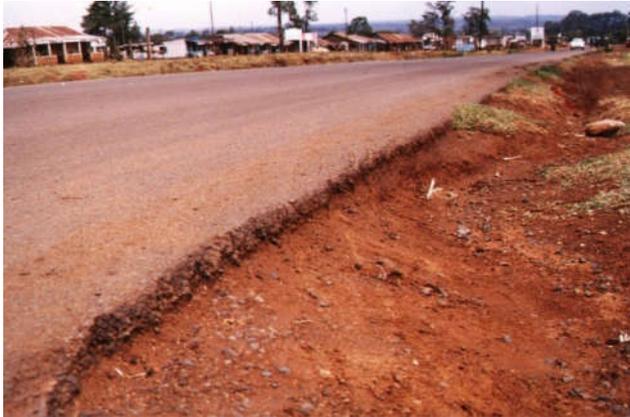
Plate 4. Eroded edge of the road along Kesses – Cheptiret Road at Kesses Centre

However, small rills could be seen on the exposed surface of the cutting. The drainage ditches along this road had silted up and became clogged up with debris and eventually became overgrown with vegetation. Vegetation growth therefore protected them from erosion. However, it was noticed that where side ditches entered cultivated private land erosion occurred. Also where the culvert was blocked and flow from the side ditch overtopped and went across the road, a certain amount of raveling took place. This was caused by abrasion of the road surface with the debris carried by flowing water. Besides, the surface run-off along the edges of the road, cattle crossing and vehicles moving on the edges of the road in an attempt to avoid potholes were some of the factors that led to wearing out of the road shoulders. The situation was aggravated when surface run-off flowed across the shoulders and down the slopes or through impact caused by raindrops or through dissolving action of water or a combination of them all.
