STABILITY EVALUATION OF SLOPES AROUND RIM OF RESEVOIR OF DIVERSION DAM OF
VISHNUGAD-PIPALKOTI HYDROELECTRIC PROJECT, GARHWAL HIMALAYA, INDIA

Vishnugad–Pipalkoti Reservoir,
Slope Stability Evaluation,
Kinematic analysis, Remedial measures.

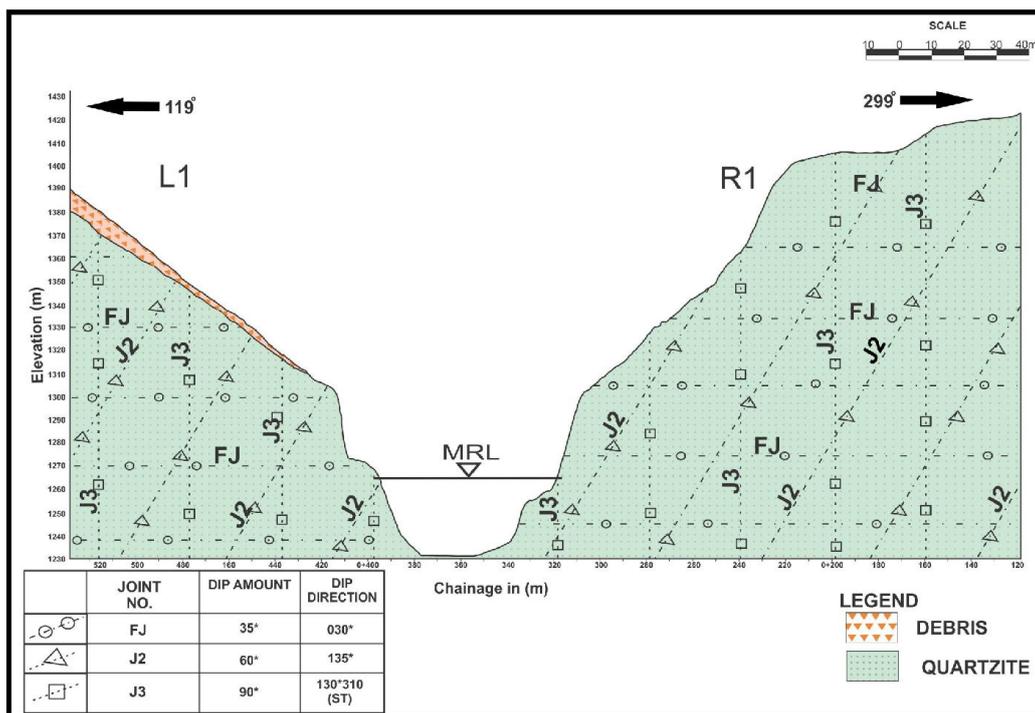
Fig. 4.1. Geological cross section of R1 and L1

- i) Section R1 (Fig 4.1): Comprises of quartzite rocks, which is fairly steep and extending for a height of 170m above the river bed. In fact, this slope section is in continuation with the slope section L1 on the left bank, It is located just upstream of the dam axis. It mainly consists of rock slope with thin debris cover at places above the reservoir level. The debris starts from EL± 1310m and further above, while MRL is limited to EL± 1269m. As such the drawdown will have no impact on the debris materials exposed above MRL. The major structural discontinuity foliation plane dips 35° towards north easterly into the hill on the right bank at an oblique angle forming stable wedges with the joint discontinuities J1 & J2.

- i) Section L1 (Fig 4.1): It is located just upstream of the dam axis. It mainly consists of rock slope with thin debris cover above, which is seen above the reservoir level. The debris starts from EL± 1310m and further above, while the MRL is limited to EL± 1269m. The geological discontinuities were plotted in a stereonet and kinematic analysis carried out (Table 4.2). The rock slope is found to be stable under static and dynamic conditions with large factors of safety against wedge failure. However, under extreme conditions i.e. dynamic condition with tension crack filled with water, the failure is likely to occur due to over toppling. Here, the site is located just adjoining the dam axis hence, the slope has to be protected adopting similar measures suggested for R1 section. The thin debris above the reservoir level shall be removed as the quantum is very less. The protection measures should continue for 100m distance on each side of the dam axis.

On the basis of stability analysis, it is recommended to adopt some slope treatments for slopes R1, R2, R3 and R4 (Table 4.3).

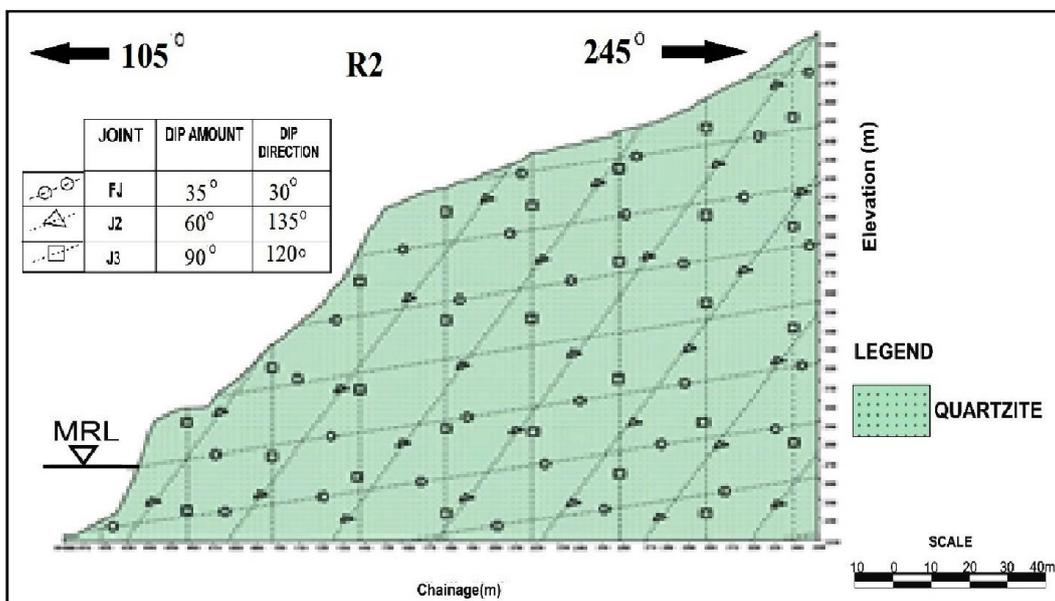
Fig. 4.2. Geological cross section of R2

- ii) Section R2 (Fig 4.2): It is a rock slope with slope angles of more than 45°. The geological discontinuities were plotted in a stereo net and kinematic analysis carried out. The analysis shows that the slope has potential plane failure instability. In view of that, protection measures as indicated for R1 section is justified in this area.

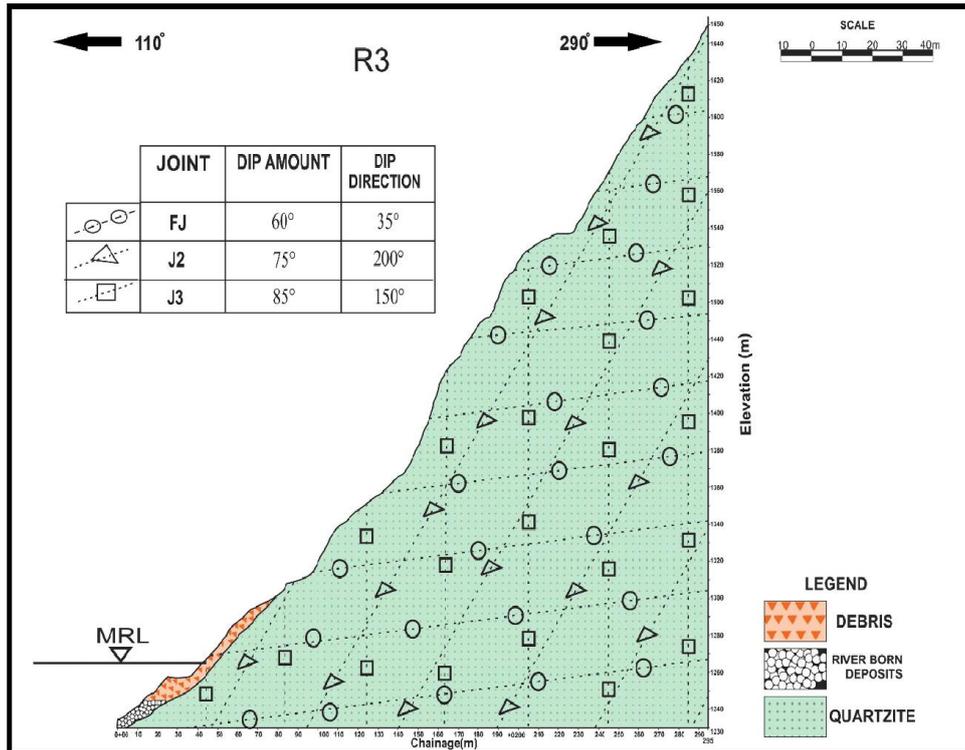
Fig.4.3. Geological cross section of R3

- iii) Section R3 (Fig 4.3): It is located about 270m from the dam site. It is steep rock slope with slope angles of more than 55°. The geological discontinuities were plotted in a stereonet and kinematic analysis carried out (Table 4.2). The analysis indicates that no wedges, either plane or wedge are formed and hence stable in nature.

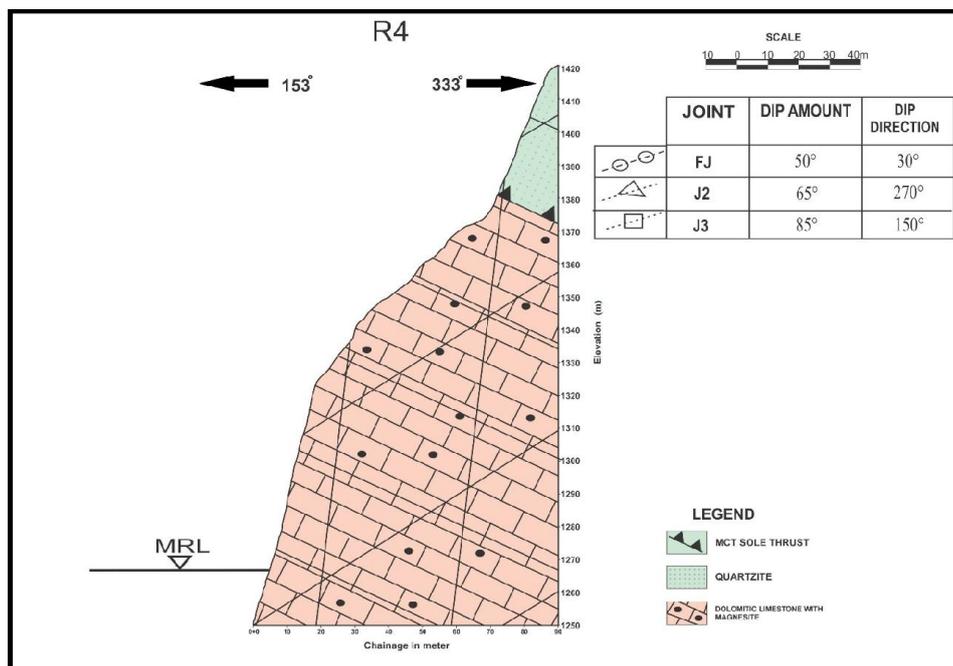
Fig 4.4. Geological cross section of R4

- iv) Section R4: This section is located on a steep rock slope (>65°) about 490m upstream of dam axis. Dolomitic limestones intercalated with magnesite are exposed at the site (Fig 4.4). The observed geological discontinuities were plotted in a stereonet and kinematic analysis carried out (Table 4.2). Since the foliation dips into the hill and other joints are not favourably aligned, no adverse wedges are formed at this site.

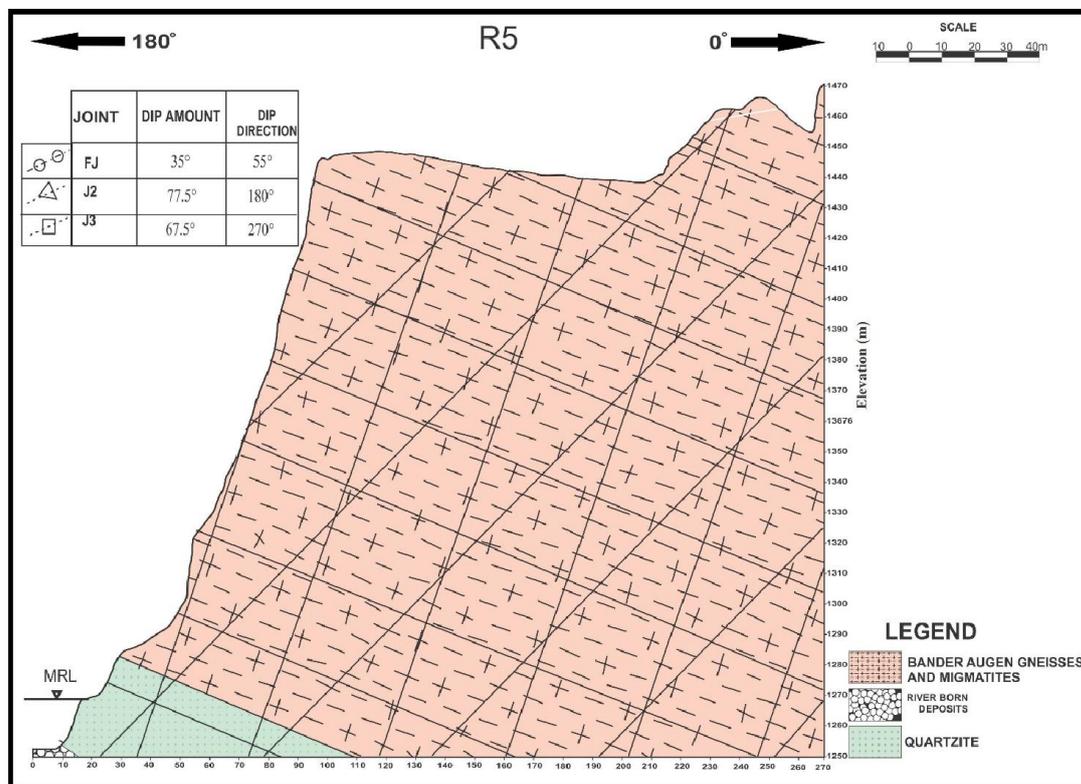
Fig. 4.5. Geological cross section of R5

- v) Section R5 (Fig. 4.5): This section is located just near the axis of the Urgam bridge on the right bank. It is located on a steep rock slope of more than 65°. Quartzites are exposed at the site. The observed geological discontinuities were plotted in a stereonet

and kinematic analysis carried out (Table 4.2). The study indicated that unstable wedges were likely to form at this site. However, since the slope is at the tail reaches of the reservoir, no measures are actually required at the site as the water will be present very close to the river bed level and hence may hardly have any impact on the stability of the slope due to drawdown.

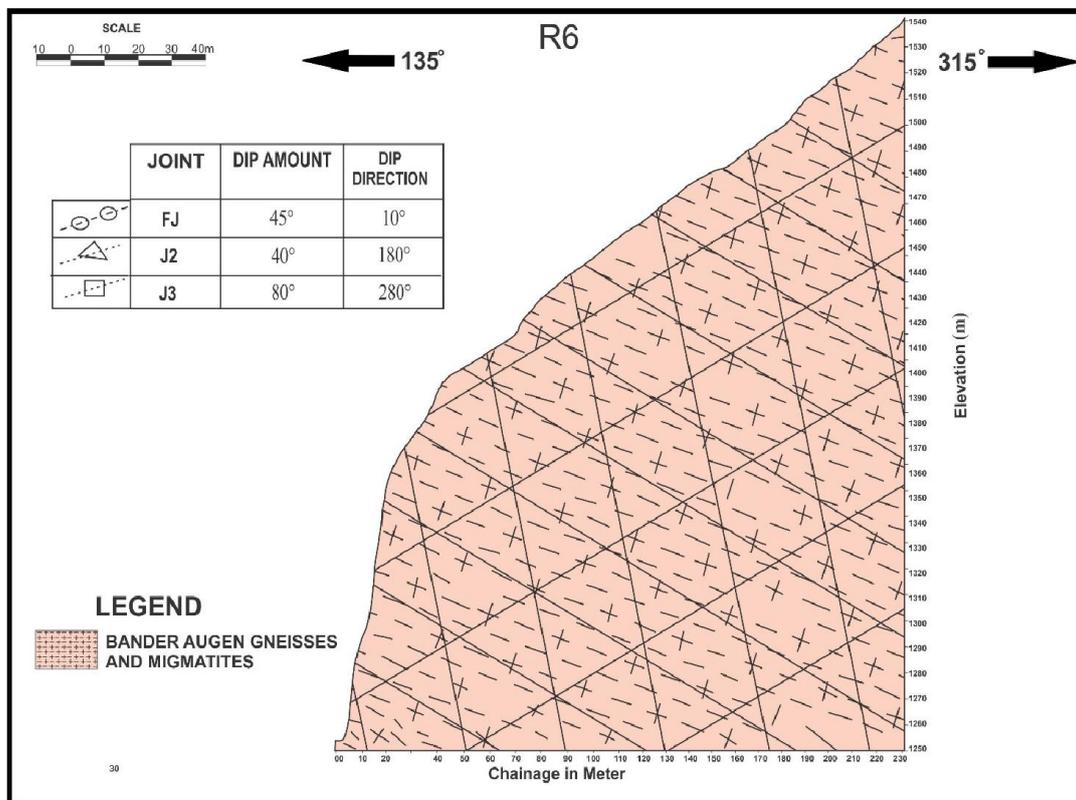
Fig. 4.6. Geological cross section of R6

- vi) Section R6 (Fig. 4.6): Is located near Kalpaganga, 2860m upstream of dam axis. It is located on a steep rock slope of more than 75°. Gneissic rocks are exposed at the site. The slope section R6 is located away from the dam axis. The MRL is located just less than 10m above the river bed and hence not likely to induce instability of rock slopes.

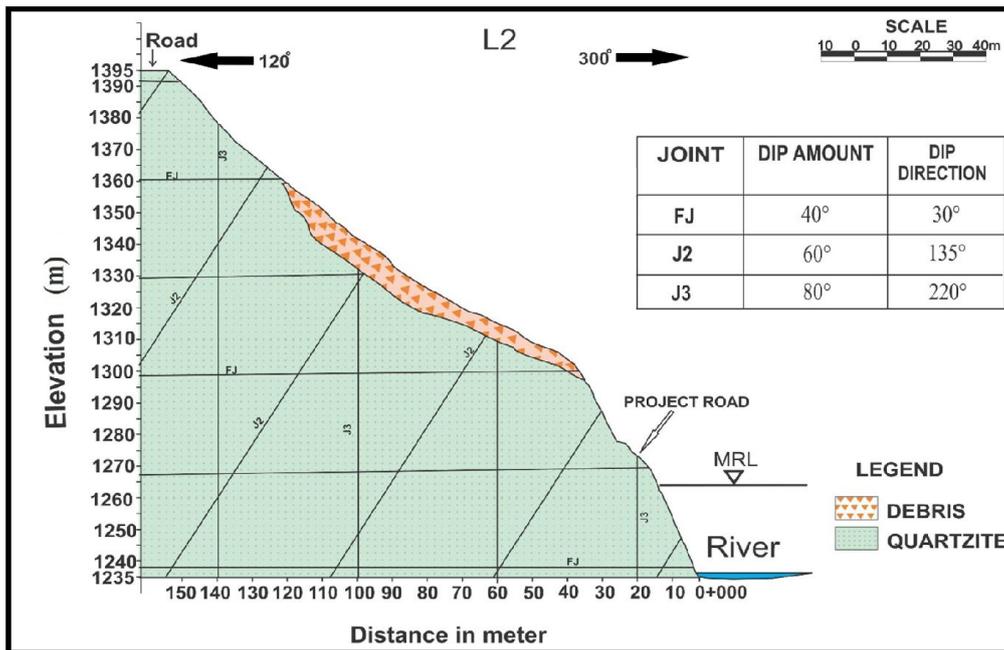
Fig 4.7 Geological cross-section of L2

- ii) Section L2 (Fig4.7): The section basically shows a rock slope with thin debris cover seen between El ±1295m and El ±1356m. The geological discontinuities were plotted in a stereonet and kinematic analysis carried out (Table 4.2). The rock slope is found to be safe against wedge failure, though some overtopping may occur in extreme conditions. However, the debris slope is not stable under the worst conditions. Due to close proximity of the section to the dam axis, slope protection work of rock and debris being adopted at section L1 should be extended to this section also.

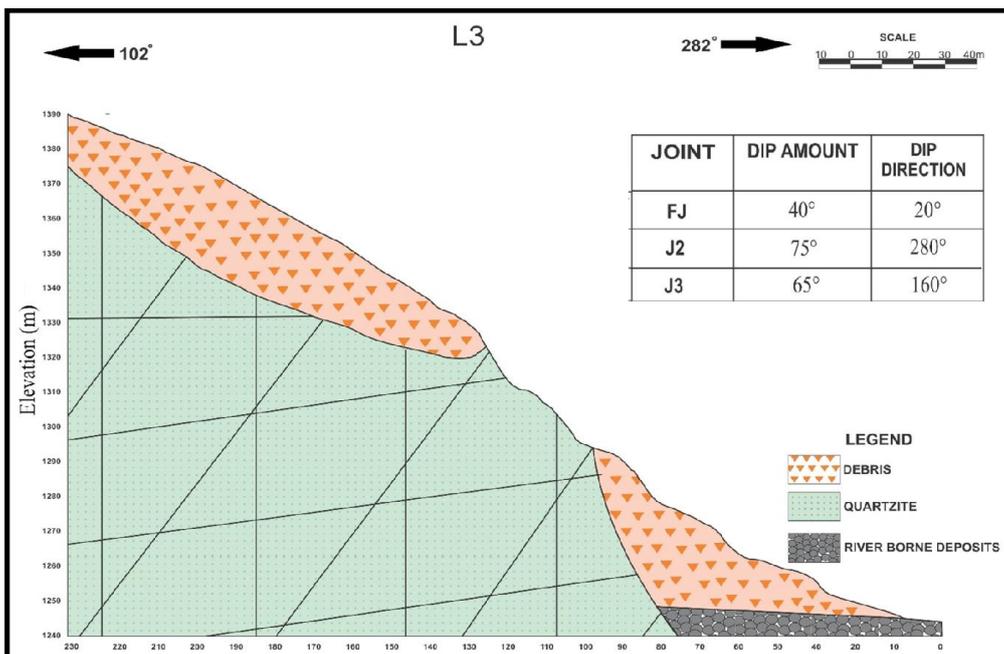
Fig 4.8. Geological cross section of L3

- iii) Section L3 (Fig 4.8): The section is located across the approach roads, which give access to the main dam from NH-58. The slopes are mainly characterized by thick debris extending from river bed to about El ± 1290m. The rock stability analysis indicates that they are stable (Table 4.2). However, the debris slope may fail under dynamic and saturated conditions. The alternate draw-down conditions of water level may induce instability in the bottom portion of debris. Since most parts of the debris mass (about 80%) lie below MRL, the failure of the debris, may not adversely affect the overall reservoir capacity.

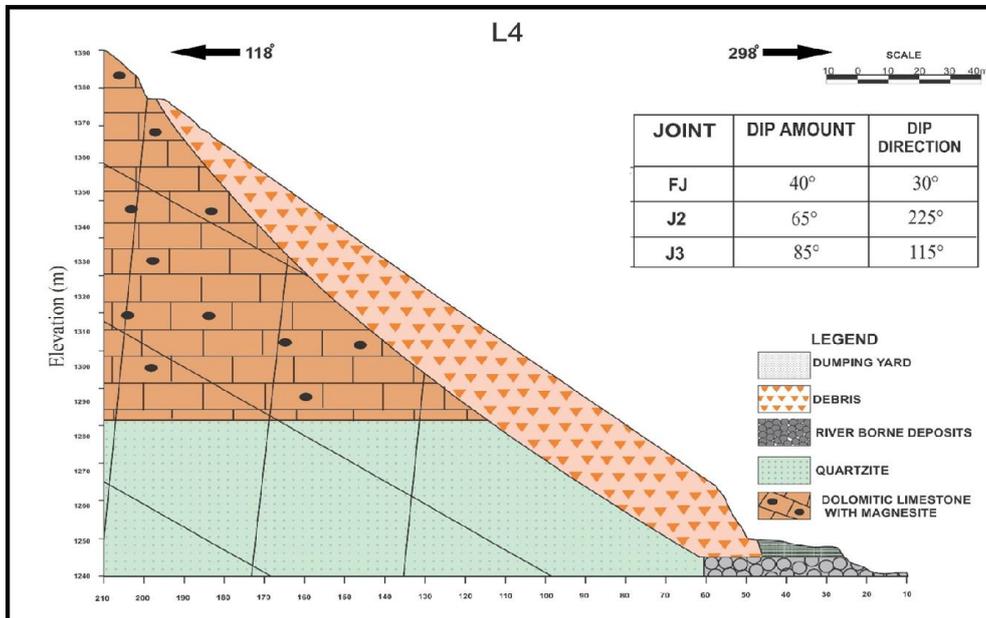
Fig. 4.9. Geological cross section of L4

iv) Section L4 (Fig 4.9): This section is located about 450m upstream of the dam axis. It is a rock slope with thick continuous debris occupying the entire slope above the river bed and extending up to El \pm 1310m close to NH-58. The maximum reservoir level (MRL) is located well in the middle of the debris slope. Though the underlying rock is likely to remain stable as indicated in the kinematic analysis (Table 4.2), the debris slope may become unstable when saturated or subjected to dynamic conditions.

A near horizontal wide terrace is present at the toe of the slope. In case of any failure of the slope above due to draw-down conditions, the slide material may be easily accommodated within wide terrace so as to flatten the overall debris slope. However, since the failed materials will remain at the toe and will get compacted by the reservoir water, it is likely to get stabilized with time.

4	L4	Rock	The underlying rock is stable. The debris slope is just stable under normal conditions. In case of failure of slope above, the slide material may be easily accommodated within terrace. It is not likely to create any harm to the reservoir.	Improve drainage through drainage holes. The slope needs to be carefully watched.
5	L5	Rock slope with debris	Unstable debris slope extends into the zone of water level fluctuations. Debris is likely to sink and slide down to get flattened to stable slope angle.	The slope should be kept under watch.
6	L6	Thick debris slope

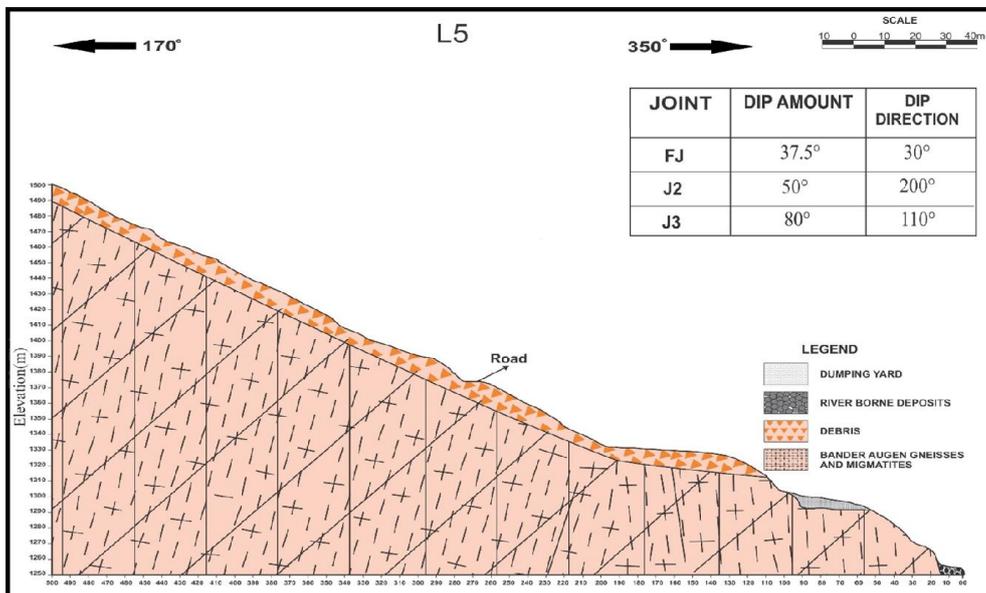
Fig 4.10. Geological cross section of L5

v) Section L5 (Fig 4.10): This section is located downstream of Urgam bridge. The slope has an average angle of 25°-30° with moderately thick (8-10m) debris materials seen above the rock slope. The debris materials extend only up to El \pm 1320m in the lower lever and further down rock slopes are present. Since the MRL is at El \pm 1269m, the top of water level will be located within the rocks and hence the debris slopes will not be affected due to reservoir water. The geological discontinuities were plotted in a stereonet and kinematic analysis carried out (Table 4.2). The analysis indicates that the slopes are stable as no unstable wedges are formed.

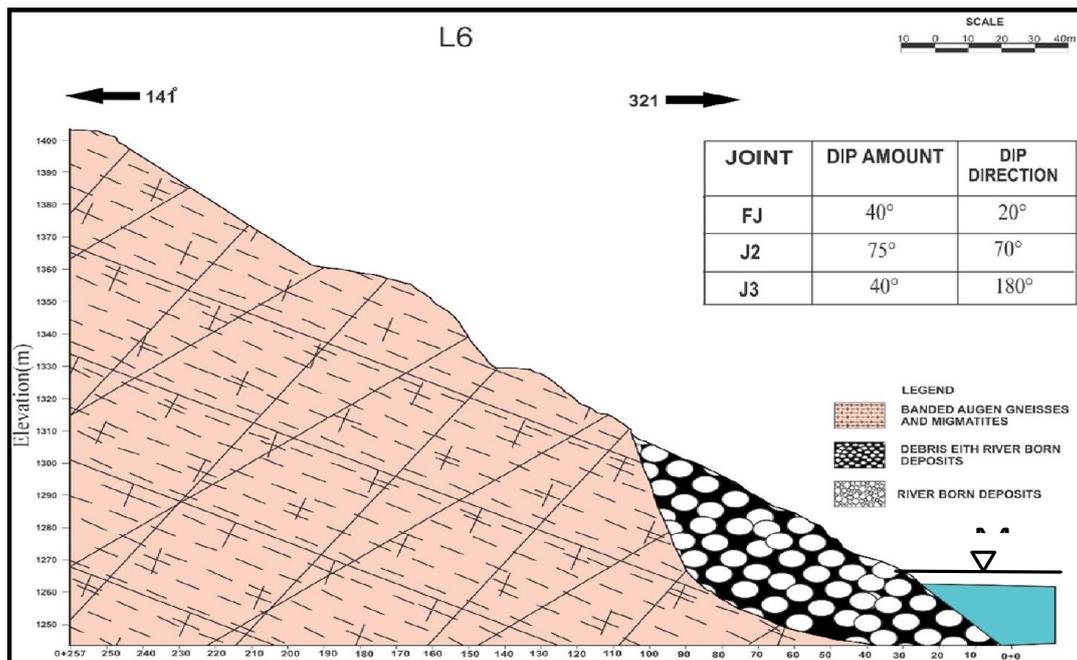
Fig 4.11. Geological cross section of L6

vi) Section L6 (Fig 4.11): This section is located about 270m upstream of Urgam Bridge. Though rocks are present in the upper reaches of the slope, a thick deposit of RBM is seen at the toe of the slope up to the river bed level. While RBM extends from river bed to El \pm 1310m, the MRL extends up to El \pm 1270m that is up to the middle of RBM deposit. During water draw-

down conditions, the alternating saturation and dry conditions may induce instability of the RBM deposit causing minor instability and sliding leading flattening of the gradient. In view of the limited extension of RBM and the slide deposit will lie at the toe area and get compacted due to reservoir water, the flattened deposit will get stabilized in a short time frame. In fact, the thick layer of RBM at the toe of the rock slope provides support to rock slope above.
