US A ENVIRONMENTAL DUE DILIGENCE PRACTICE CASE STUDY ON AN INDUSTRIAL SITE
LOCATED IN CARAS-SEVER IN COUNTY ROMANIA

This paper focuses on the application of the usual approach for the environmental assessment of sites which are the subject of a real estate transaction or which are brownfields. The existing Romanian legislation in this field must be completed with other available regulations. In addition, the success of the approach is provided by a rich professional experience of the environmental assessors involved. The case study presented in this paper refers to the approach taken to investigate and quantify their potential historical pollution for a former industrial land with an area of 8840 m². In this respect, both the international and Romanian standards were applied.

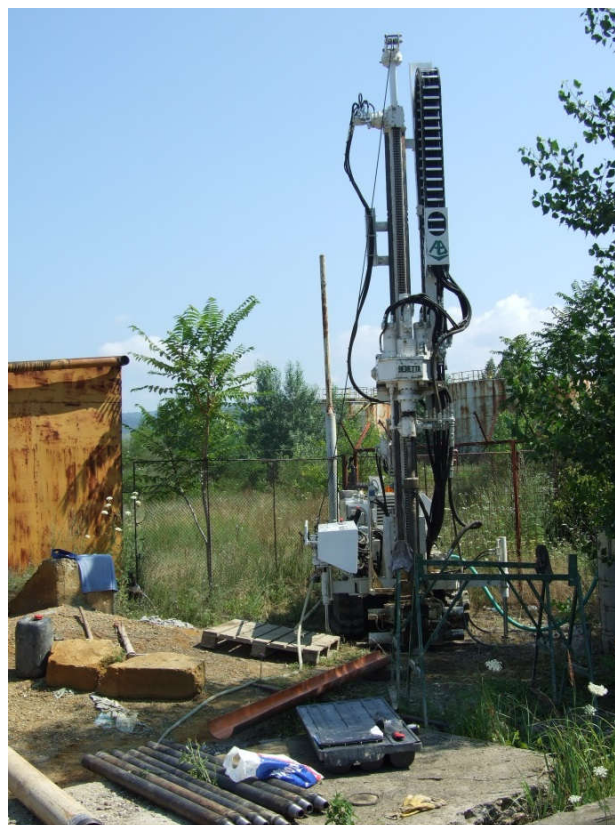
Figure 3. Drilling of borehole F1

A total of 24 soil samples and 4 groundwater samples were recovered in order to be analysed in the analytical laboratory. Samples were stored in pre-cleaned glass containers; the sampled quantities were decided according to the type of analysis and the laboratory requirements. The sample containers were labelled with a unique sample identification number and transported to the analytical lab (certified according ISO 17025:2001) by a consultant representative. An example from the drilling operations is shown in Figure 3.

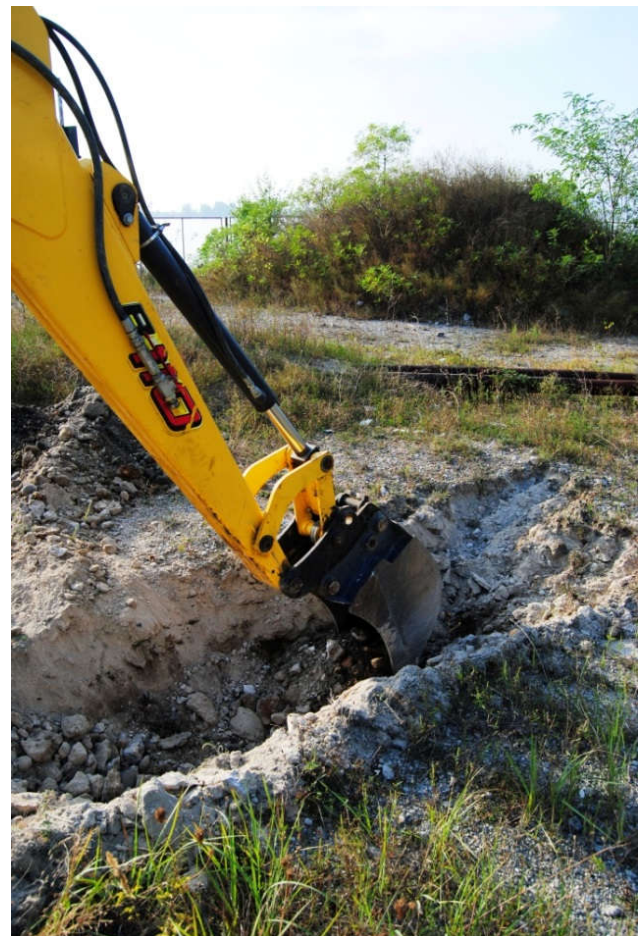
Figure 5. Digging of SP4

These activities were performed by observing the specific requirements of the national and international standards and by complying with the appropriate QA/QC measures. The bulk of the excavator was carefully cleaned after the execution of the each sampling pit. The preservation of the samples in adequate

conditions (paying more attention to cleaning of the excavator's bucket after the execution of each sampling pit) and their transportation to the laboratory were also ensured by consultants. The main field observations on collected samples are presented in the Table 3. It can be seen that since the time of sampling, for most samples was felt the smell of hydrocarbons. Later, it was confirmed by the results obtained in the analytical laboratory. Samples were analysed using the gas chromatography (GC) method, in order to highlight the percentages of different fractions of hydrocarbons in the recovered samples. The analytical results are presented in the next table. Samples with exceedances of thresholds values are highlighted in red (for intervention threshold) or blue (for alert threshold). The analytical results for the samples recovered during Phase III ESA were graphically interpolated for a relatively accurate view of the spatial extent and volume of contaminated material (see Figures 6).

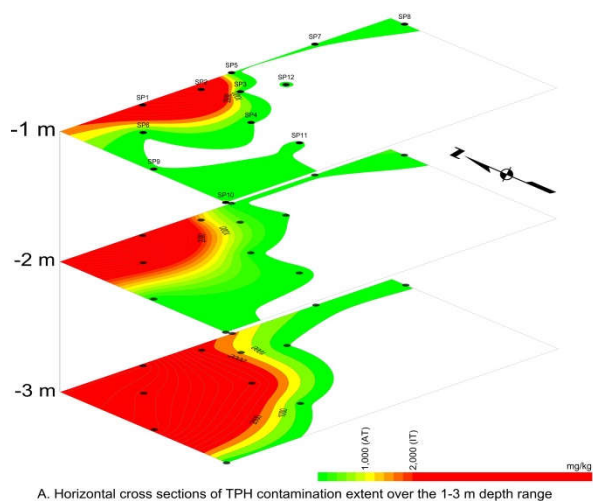
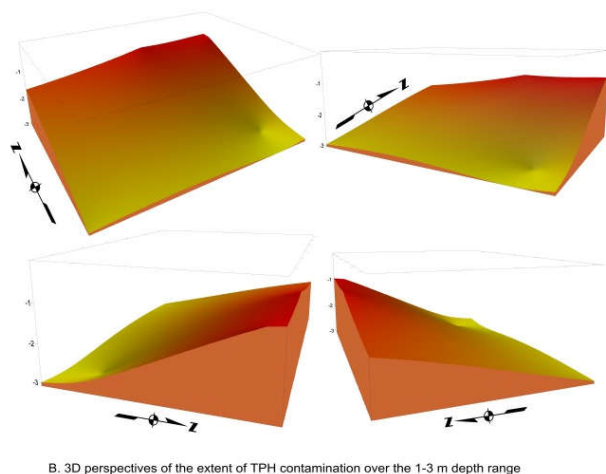
Figure 6. Horizontal cross section of TPH contamination (2D and 3D perspectives)

The analytical results based on intrusive soil investigation during Phase III ESA revealed exceedances of the legal thresholds, as follows:

- Concentrations in 11 samples, recovered from 6 of the sampling pits (SP1, SP2, SP4, SP6, SP9 and SPx) exceeded the intervention threshold for TPH, the depth of contamination being more than 3 m;

- Three samples collected from 3 of the sampling pits (SP2, SP3, SP5) revealed exceedances of the AT for TPH;
- The bulk test pits (8 of 13), hydrocarbons concentration increases with depth;
- The identified fractions of hydrocarbons range from C10-C14 to C14-C20 and C20-C26, with the highest weight in the C14-C20 fraction. Given the results, it can be deduced that the contamination consists of high concentrations of diesel fuel.

After three successive stages, the environmental assessment for a former industrial site located in Moldova Noua town confirmed the presence of an historical pollution with petroleum hydrocarbon. The contaminated area is situated in western side of Plot no. 2 and in the north-western corner of Plot no. 1. As the samples collected from the off-site sampling pit, located in the close northern vicinity of Plot no. 2, revealed high exceedances of the IT for TPH, it was confirmed that the source of contamination were the 3 nearby ASTs. Based on analytical results, the estimated volume of contaminated soil with hydrocarbons is of approximately 1,500 m³, over a depth ranging from 1 to 3 m, on a total surface of approximately 700 m². Moreover, the groundwater table was affected through progressive infiltration of the contaminant. Soil and groundwater remediation works are required on the subject property, so the environmental assessment must be continued with Phase IV and Phase V.
