## RESEARCH ARTICLE

### AN ENQUIRY INTO THE EVOLUTION AND IMPACT OF HUMAN INTERFERENCE ON THE CHURNI RIVER OF NADIA DISTRICT, WEST BENGAL

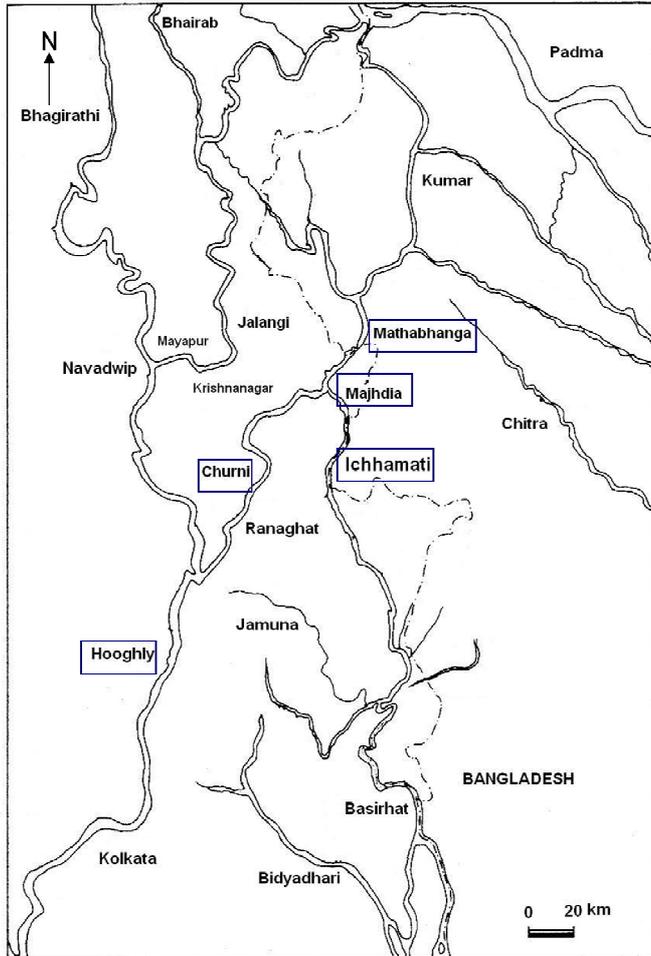
Fig. 1. Mathabhanga-Churni-Ichhamati River System

Bhagirathi-Hooghly near Chakdaha (Fig. 1 and 2). The river Churni is significant because it is a major source of surface water, it provides an income source for thousands of fishermen, it supplies fish as food to 0.3 million people nearby to the adjacent small towns of Ranaghat and Krishnagar.

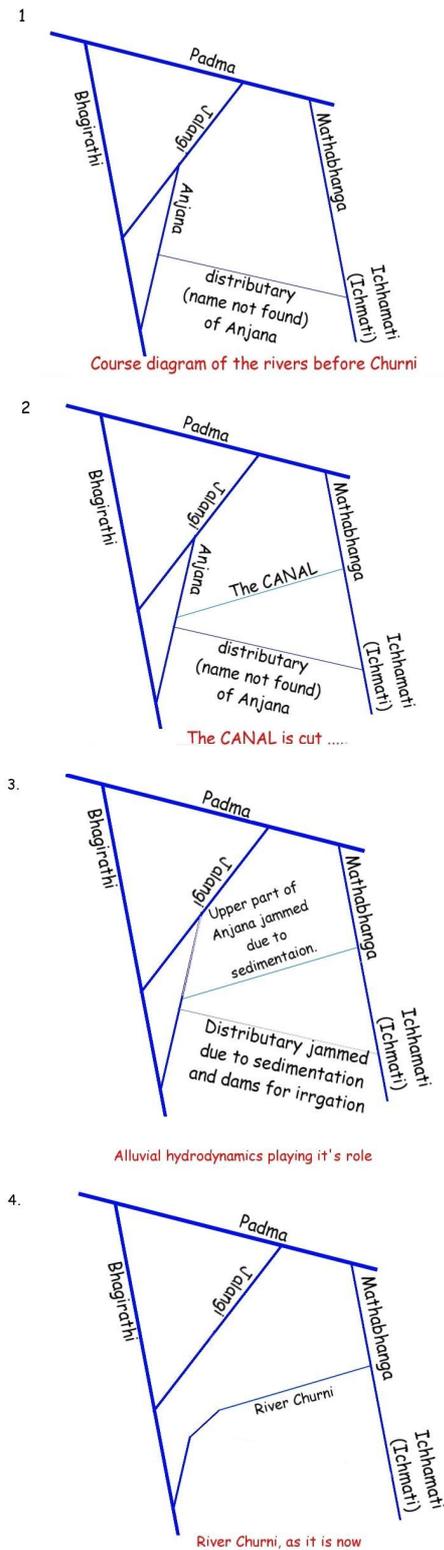
Fig. 3. Simple line diagram depicting the evolution of the Churni river

River Churni was most probably an artificial canal, not a true river. Local history says, during 17th Century, the King of Nadia (that time Nadia was a kingdom, now a district of West Bengal) was Maharajah Krishna Chandra. River Churni was dug at his orders as a moat against the Bargees or Bergirs of Maharashtra. At that time, there was

another important river here. It's name was Anjana. It had originated from Jalangi River, and confluenced with River Bhagirathi. A distributary emerged from Anjana near Jatrapur (Yatrapur), and confluenced in Ichhamati. At that time the lower part of Mathabhanga was known as Ichhamati, same as now. The flux of Anjana and the distributary increased with water of the canal. Later, the distributary was filled up artificially, and alluvial sedimentation jammed the upper part of Anjana. The canal and the lower part of Anjana is today's Churni (Fig. 3). That is why the river is also referred to as Kata Khal (dug canal). Thus, the river has been born as a result of human interference.

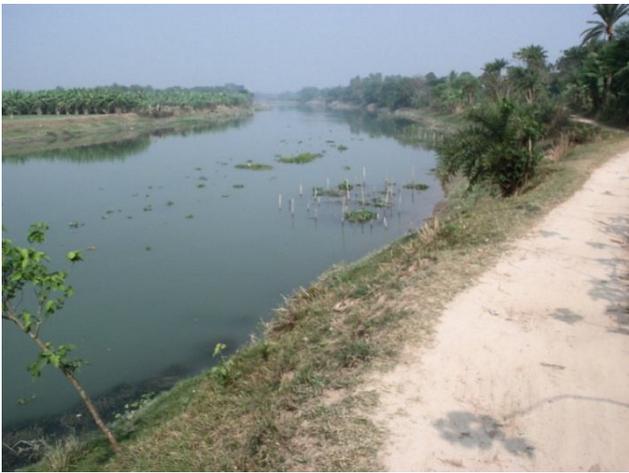
Plate 1. River Churni flowing beside Payradanga in Ranaghat P.S.

The river (Plate 1) has erratic water flow causing floods over large tracts spilling over the banks during torrential rains, but remaining practically flowless during dry season. Link of the river with Padma remains cut off for most part of the year. Only in floods there may be some inflow from Padma into the river. The repetitive occurrence of the 9-metre contour in the area indicates that the ground slope does not have a persistent direction. The river is at a loss to find a perceptible slope and consequently have extremely intricate meandering courses. At some places the course of the river has taken a complete turnaround.

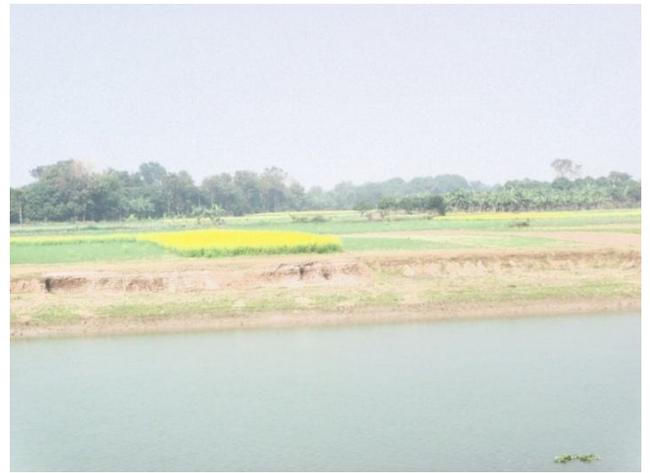
Plate 3. River Bank Cultivation & Cutting of Soil alongside the river bank

- Encroachment along the river bank by the illegal migrants especially from Bangladesh.
- Agriculture is practiced in an unscientific manner along the banks of river (Plate 3).

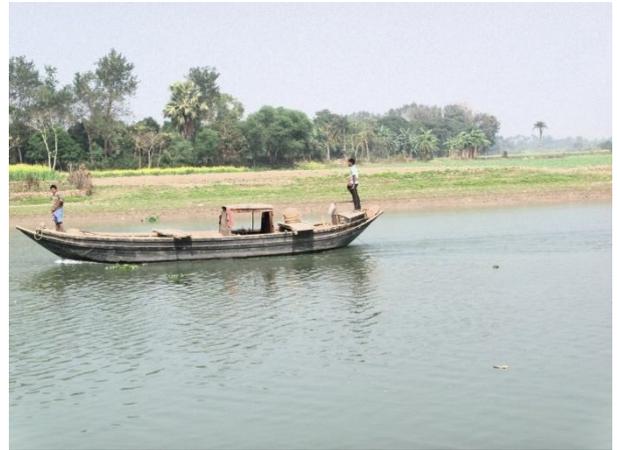
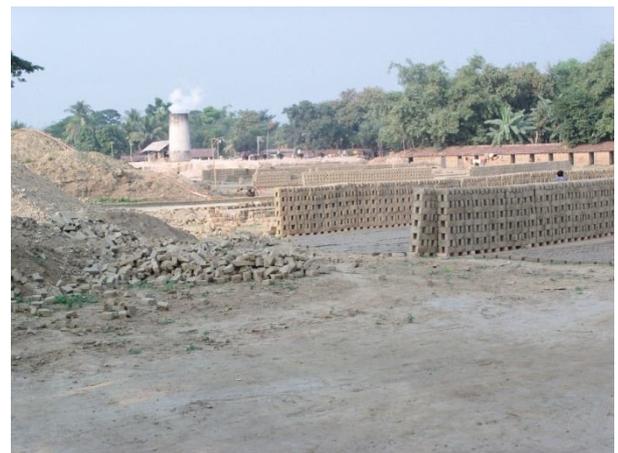
Plate 4. Transfer of soil in mechanised boats to Brick-kilns alongside the Churni

- Soil is being cut at an alarming rate along the banks of the rivers for supply to the brick kilns (Plate 4).
- Faulty anthropogenic structures like bridges have been constructed on the river.

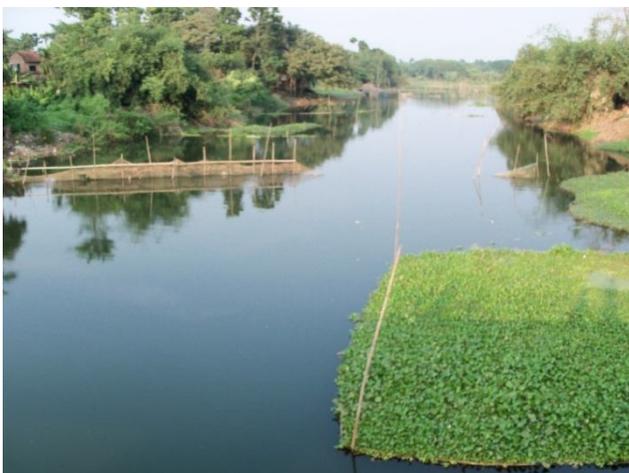
Plate 2. Obstruction in the flow of the Churni river by bamboo-made barrages

- Bamboo-made barrages at several places on the lower stretches of the river obstruct the normal flow of the water (Plate 2).
- Retting of jute in the river is another significant issue connected to the deterioration of the river.

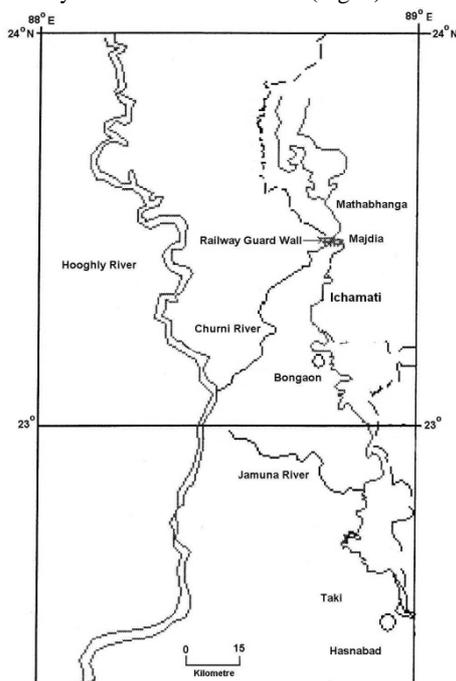
Fig. 4. Railway Guard Wall at Majdia obstructing the water flow into the Ichamati

causes of silting of the river was construction of guard wall for Railway Bridge at Majdia (Plate 5).

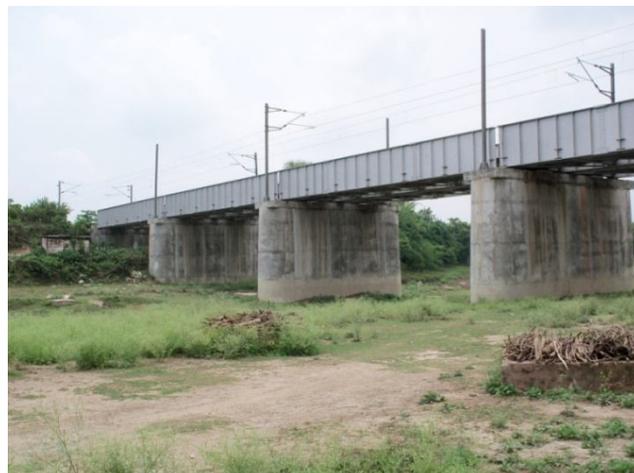
Plate 5. Railway Guard Wall at Majdia on the Churni

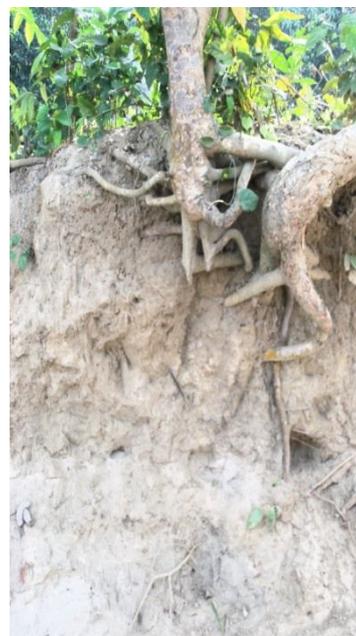
Plate 6. Bank Collapse caused by the Floods of Churni River

- Siltation in the river bed owing to the residues left after the retting of jute
- Increased intensity of Floods due to loss of depth of the surface water bodies due to excessive siltation
- Soil Erosion and Bank destabilization (Plate 6) due to river bank cultivation and cutting of soil along the banks
- Raising of river bed is a significant impact of the construction of railway bridge on the Churni river at Majdia (Fig. 4). While the bed of the Ichamati river is 14 feet higher than that of the Mathabhanga, that of the Churni is lower than Mathabhanga by six inches. During the lean period the level of water in the Mathabhanga is higher than that of the Padma. As a result, no water enters the Ichamati during the dry season. One of the

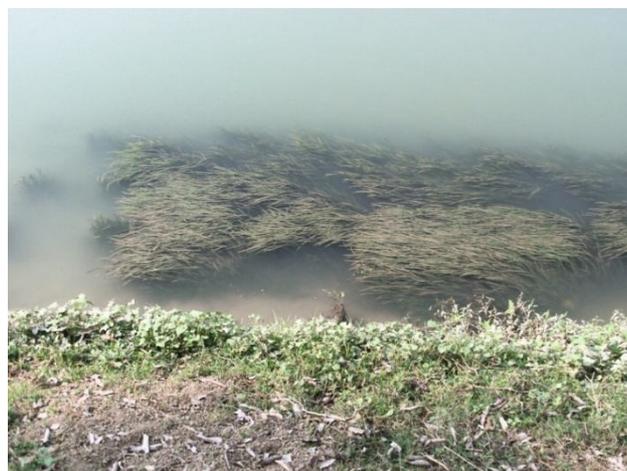
Plate 7. Weed infestation in the Churni River

- h. Weed infestation (Plate 7) and Eutrophication in the river have taken place due to high levels of organic matter, nitrogen and phosphorus content in the water.

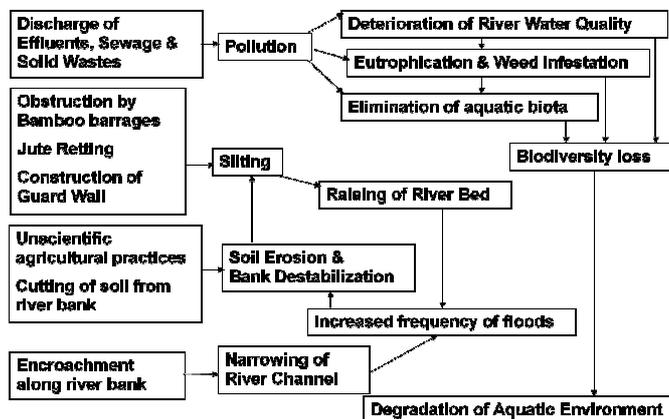
Fig. 5. Impact of Human Interference on the Churni River

- i. Elimination of indigenous aquatic flora & fauna has taken place owing to pollution. 63.6% of fish species appeared to have been eliminated from the polluted Churni river since 1983. Out of 44 fish types found in 1983, only 16 are found today in the Churni. *Labeo bata* (Hamilton), *Puntius sophore* (Hamilton-Buchanan), *Mystus bleekari* (Day), *Rita rita* (Hamilton), *Setipinna phasa* (Hamilton), *Mugil korsula* (Forsk.) (Forsk.), *Xenentodon cancila* (Hamilton), have been completely eliminated from the river. The fishes of the river Churni have likely responded to ecosystem stress, resulting in the degradation of community structure. Decline in the number of fish species in turn affects the livelihood of fishermen. The people living alongside the river treat it like an open drain dumping almost anything and everything (even dead bodies of animals as well as faecal matter) into the river. All these have led to the overall degradation of the aquatic ecosystem of the Churni river (Fig. 5).
