## RESEARCH ARTICLE

### ASSESSMENT OF RAINWATER MANAGEMENT PRACTICES AND LAND USE LAND COVER CHANGES IN THE MEJA WATERSHED, JELDU DISTRICT, OROMIA, ETHIOPIA

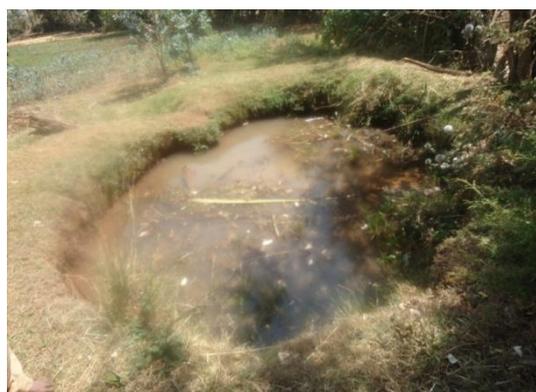
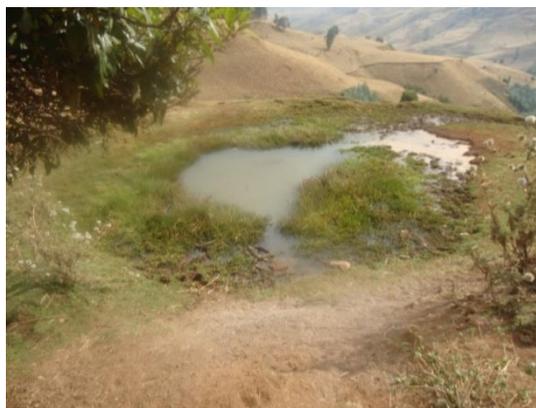
**Figure 3. Privately constructed pond in Tullu Gura kebele (A) and unprotected community pond in Sariti kebele (B) of the watershed under study**

ponds that are intended to store water for later use were identified of which three were constructed by community during the Derge regime (about 28 years ago). One pond was constructed privately in the recent time (3 years ago) in Tullu Gurra kebele. The private pond had a circular shape and was 3 m wide and 2 m deep whereas the community ponds which were found in Sariti and Tulu Gura kebele were circular in shape and about 6-9 m wide and 2-3 m deep. Currently the community ponds were neglected without maintenance; grass growing in it and filled with sediment. The privately constructed pond was also not properly protected as it was filled with broken woods, leaves and grasses. Even though the ponds were not properly protected, they are still used mainly for livestock and small scale irrigation to grow potatoes, onion and vegetable and tree seedlings. A success story with the privately constructed pond was that; the owner prevented the pond from drying off by diverting the stream which was about 180 m away from the pond and he was able to produce cabbage, onion, potatoes and seedling of eucalyptus tree on his farm in the dry season and was able to secure food at his household level (Figure 3). The report of Alem (1999), cited in Girma (2009), indicated that ponds were the main RWH structures in the Ethiopian Rift Valley where groundwater was deep and other sources of water were not available. According to his report farmers used ponds to collect water for growing vegetables and fruits around homesteads for markets and home consumption.

The survey results showed that none of the ponds were performing as intended in terms of storing/retaining harvested runoff. The owners indicate that the poor performance was a consequence of high water losses arising mainly through seepage, evaporation, siltation problems occurring as a consequence of lack of maintenance. The same problems were reported by Girma (2009) in his study on identification of potential rainwater harvesting areas in the central Rift Valley of Ethiopia using a GIS based approach. In general, the ponds were left unprotected allowing livestock to drink directly from the pond and silt, leaves, grasses and woods were being accumulated in it. For well functioning of such ponds, there had to be full participation of the entire community. Thus strong community organization was required to mobilize labor for operation and maintenance.

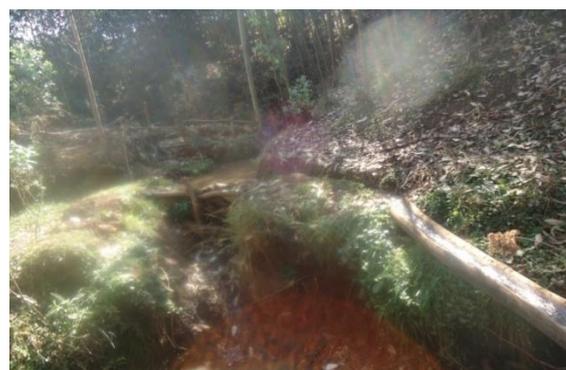
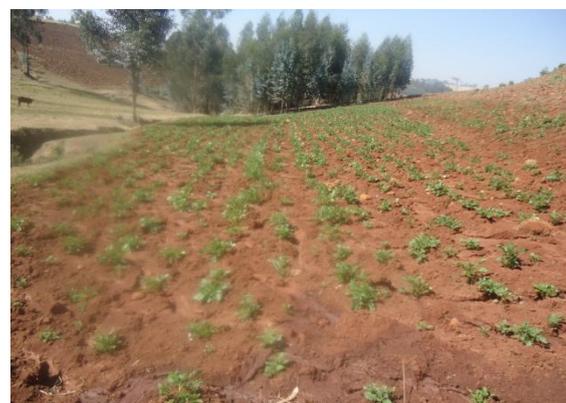
**Figure 4. Privately constructed local check dam (A) and potatoes farm (B) being cultivated using the dam in Chillanko kebele**

About 43.5% of the respondents practiced perennial stream or river diversion by locally constructed check dams from locally available materials such as soil, stone, wood and leaves. Most of these structures were constructed privately in the upper parts of the watershed on nearby spring or streams for household consumption and for livestock. One locally constructed check dam diverted from Laga shasi stream in Chillanko kebele was among a productive check dams observed in the study watershed. The check dam was constructed from eucalyptus tree. The diverted water was used for potato cultivation in the upper part of the watershed (Figure 4). The potato grower said that he had used the same stream for potato, onion and cabbage cultivation for about 16 years. However, he was no longer able to use it because of the

reduction of the flow of the stream. This forced him to irrigate the current potato field by share arrangements with the owner of the land. Most of the respondents complained about the scarcity of water in the stream and short durability of the locally constructed check dam. On the other hand, it was never tried to divert the big Meja River in the upper part of the watershed by constructing local check dams since it flows in a deep gorge. This prevented farmers from diverting water from the Meja River for irrigation. To solve these problems two respondents were using motor to cultivate potato and onion in the upper part of the watershed. The use of water pumps enabled them to maximize their yield and secure food at the household level. According to the perception of the owners of the water pumps, buying the fuel, spare parts and maintenance of the motors were among the major challenges they face.

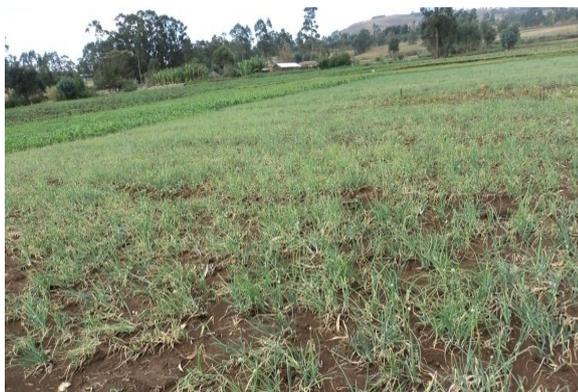
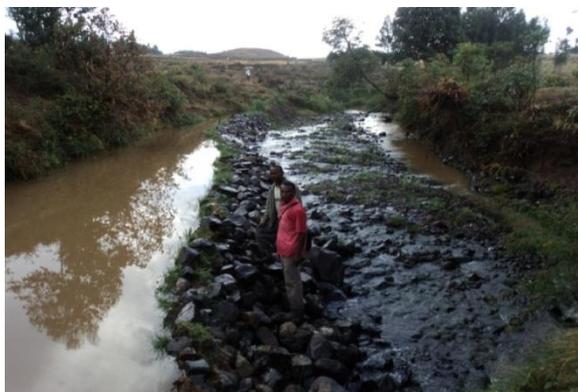
**Figure 5. Irrigated maize and onion farms in Kolu Galan kebele (A) and locally constructed Meja check dam in Tulu Gurji kebele (B) in the watershed**

In lower part of the watershed the use of check dams (Figure 5) were largely practiced to divert perennial streams and Meja River. The terrain nature was suitable for wide range of small scale irrigation system for production of potato, maize, barley, onion and cabbages. According to the respondents, the major limitation to use irrigation was the scarcity of water. The most widely used water sources for small scale irrigation system in this lower part of the watershed were the Meja River, the Laga Kile and the Laga Jeba streams. With the help of these water sources the beneficiary households were able to produce crops twice a year from their farm land. Laga Jeba stream originated from Kollu Galan

The Meja River which is the largest and only river in the study area is originated from Galessa area. It passes the watershed under study from top (around Sariti and Hinto Dale kebele) to bottom (Chobi Sirba and Kollu Galan kebele up to bridge on Chobi road). There were four check dams locally constructed mainly from stones, soil and woods at Bicho (one check dam), Tullu Gurji (two check dams) and Kollu Galan (one check dam) kebele at intervals along the course of Meja river every year during the dry seasons. The check dam in Tullu Gurji was constructed for small scale irrigation purposes serving about 400 households which were organized into 5 zones from two kebele partly found in the watershed. These 5 zones were about 5 gasha (200 hectares) in area as reported by the respondents in the study watershed. The length of the check dam was approximately 12 m and was constructed by the communities from the 5 zones. Maize, potato and onion were the main crops cultivated in the irrigation system. As in the case of Laga Jaba, there was also water committees which were even further organized in hierarchical manner for wise use of Meja water for irrigation system. Most of the respondents mentioned that the main problems in using the Meja River were the difficulty to construct a dam, maintenance problem and scarcity of water for those farmers located furthest from the diversion. There was also the problem of breaking down of the check dams by water force every year during summer season.

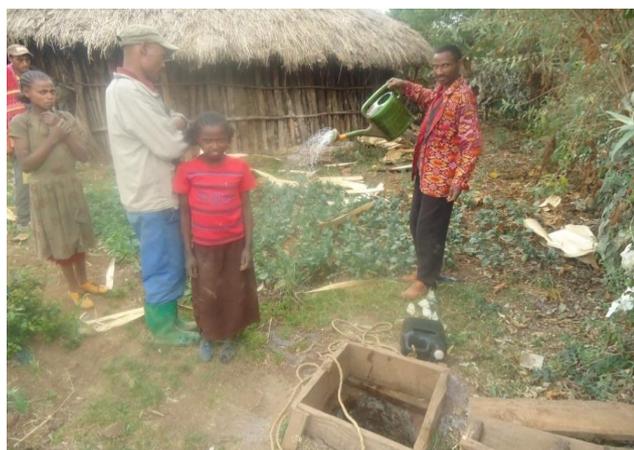
Figure 6. Privately constructed open well in Hinto Dale Kebele in the study watershed

The survey data showed that 4% of the sampled households had private open wells in their garden constructed by an expert paid by the owners themselves. The open wells, which the people call "Ella", were circular in shape and are on average about 1 m wide and 9 m deep (Figure 6). As most owners responded, the open wells were full of water during the rainy season and with very little water during the dry season. They used rope for lifting mechanisms without pulley system. All of the surveyed households with the open wells used water for washing and cooking purposes. They also use the stored water to irrigate small plots in the garden to produce vegetables for home consumption and to raise vegetable seedlings. One of the respondents in the Sariti kebele complained about the insufficient amount of water in the well during dry season even for household consumption and the problem of cleaning it without the expert. The other respondent in Hinto Dale kebele raised the problem associated with lifting mechanism in that the rope sometimes cut and fetching materials such as buckets left in the well.

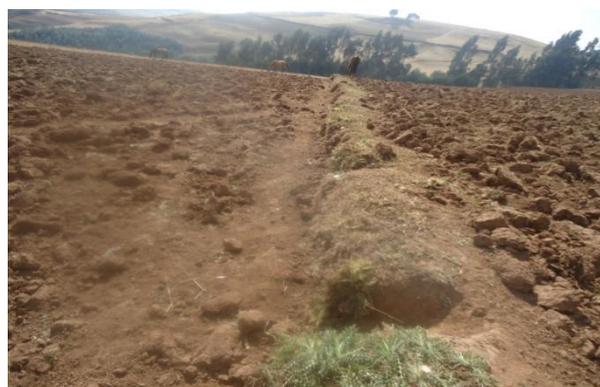
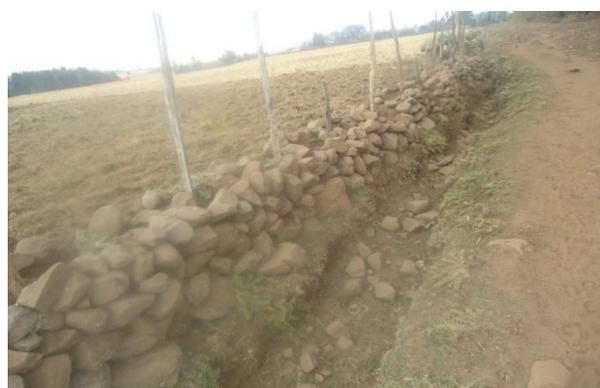
Figure 7. Earthen (A) and stone (B) bunds used in the watershed under study

Fifty two point four (52.4%) and 9.7% of the respondents in the study watershed used earthen bunds and stone bunds on their farm land, respectively (Figure 7). Most of the earthen bunds were constructed during the Derge regime (about 28 years ago) by the community. The earthen bunds varied in length and height (on average about 50 m in length and 50-75cm in height) and were constructed horizontally on the land which is prone to soil erosion by runoff water. High labor and the lengthy time required for construction were the reasons for not constructing the structure at the household level according to 11.3% of the respondents. Eight percent (8%) of the respondents, however, reported lack of information and

training about the structure for not being constructed at household level. The earthen bunds were mainly constructed for increasing the time for water infiltration into the soil and for runoff protection purposes. Besides this most respondents used the structure as boundary for separation of pieces of plots from one another (wheat plots from Barley ones) and also for separation of land of one owner from another. In some places of the study watershed some of these structures were broken down by excessive runoff water and by livestock trampling. The stone bunds observed in the study watershed were constructed horizontally (in average 20 m in length and 1.25 m in height and used for similar function as that of earthen bunds. They were constructed in the current time privately.

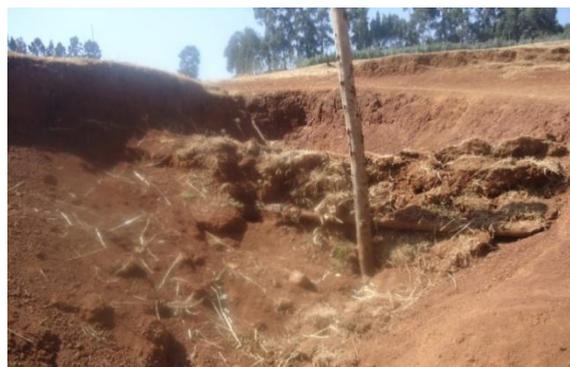
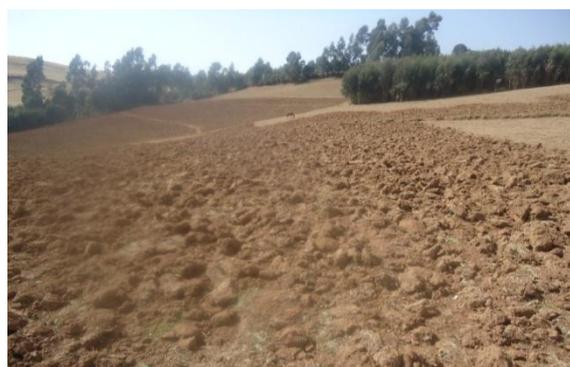
Figure 8. Gully plugging (A) and deep tillage (B) used in the study watershed

The undulating terrain nature and the high potential of rainfall in the study area were responsible for the formation of runoff following roads, furrows and rill erosion, there were a number of gullies being formed in the study watershed. According to the surveyed households there were only 1.6% gully plugging structures constructed privately in Tullu Gurra and Bicho kebele from locally available structures such as wood, leaves, soil, and stone in the past summer (Figure 8A). Even these existing structures, observed by walking through the catchment, were not fully constructed and hence runoff water may easily break them down. This implied that such type of gully erosion management by gully plugging needs community participation so as to fully construct and easily control the erosion problem in the area. According to most respondents, they practiced deep tillage (about 15-20 cm deep by local ploughs) on their farm land on

which they grow crops starting in October every year. This practice was common and used by the farmers mainly for preparing the land for crop production and for increasing the time for infiltration of rainwater into the soil profile (Figure 8B above). Deep furrows were on average 25 cm deep and constructed mostly by farmers themselves for diverting runoff to reduce the washing out of their farm land. This practice was also very common and adopted from parents and neighbors. The main problems in using deep furrows were that most farmers did not take care of the runoff water once it passed from their farm and they paid no attention to the direction of the furrows as downward directed once were further responsible for gully erosion formation.
