TEMPORAL CHANGES IN BHYARI LANDSLIDE AND ITS EFFECTS ON ENVIRONMENT
(GARHWAL HIMALAYA)

D. D. Chauniyal and *Surajit Dutta

Citation: Chauniyal, D. D. and Surajit Dutta, 2015. "Temporal changes in bhyari landslide and its effects on environment (Garhwal Himalaya)", *International Journal of Current Research*, 7, (7), 18805-18809.

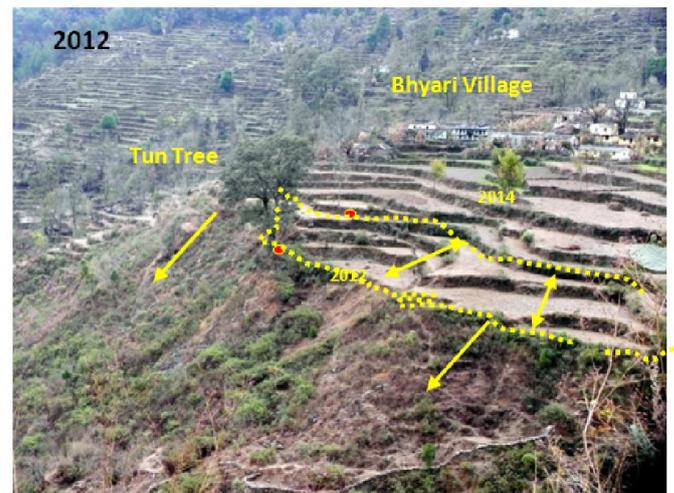
Successive stages of submerged area in the landslide zone

About 2.03% area of the landslide was increased in between 2012 and 2014. The statistical matrix (Table 3) shows that the area of cultivated land is submerging into slide zone and converting into waste land (Plate 1 & 2).

Table 3 shows that about 5.51 hector cultivated land of Bhyari village has been submerged into landslide zone since 1958. Its recent evidences can also be observed in the Plate 1 & 2. Here was a *Tun (Toona Ciliata)* tree at the boundary of cultivated site up to 2012 (Plate 1). But during 2014 field investigation, it was found that the tree was slumped down along with

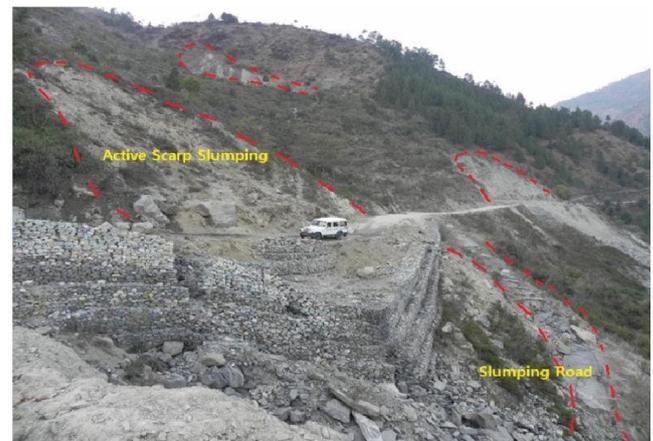
Plate 3. Slumping of motorable road

is also changing every year because of slumping process. Every year 375m road is realigned on the landslide zone. Most of the changes are noticed after the monsoon season. Therefore, the wet season is one of the most triggering factors of landslide in the mountain region.

Numerous affects of Bhyari landslide can be observed on local environment. Rock fall from scarps, sliding of fields, slumping and tilting of terrace fields (Plate 1 & 2), rotational tension cracks, toe cutting by river, new headword scarps and lateral erosion by the streams, submergence of motor able road (Plate 3) and collapse of houses (Plate 4) are the prominent features about the recurrent activation of Bhyari landslide. Although such type of events are not happened every year but after a long time some mega events occurred in the mountain region of the Himalaya. It is noted that this 2013 mega event thoroughly created the instability all over the Bhyari village and surrounding environment. Field investigations show that whole slope of Bhyari landslide is unstable which creates instability effects. Bhyari village is located at the crown of the active slide zone. Due to the slumping and rotational slide numerous cracks were developed on the cultivated land and houses. Therefore, out of 27 households the 15 families of Bhyari village have been left the village and shifted to other places. Only 12 very poor households are living in the village that cannot effort to move other places. About 3 houses were tilted, 5 houses were affected by cracks on the walls and 3

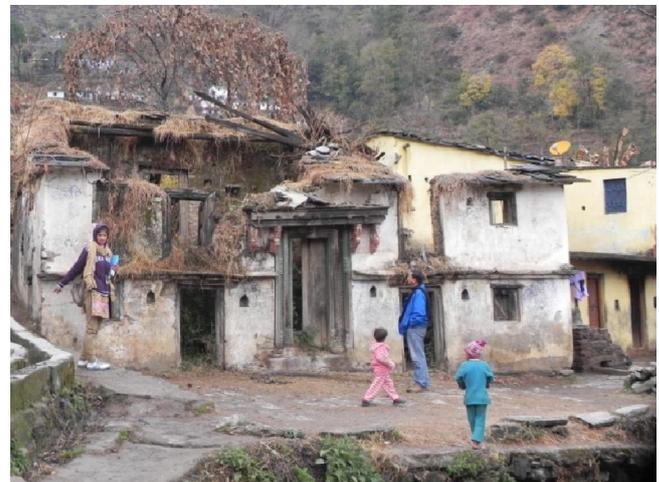
Plate 4. Damaging houses due to slumping

residential and 2 cattle shed have been abundant in the Bhyari village (Plate 4). Similarly, out of 22 households, 7 households of Chapeli village have also been left the origin place and shifted others. Now another rehabilitation problem has arisen in the villages which are a matter of further investigation.
