RESEARCH ARTICLE

A CASE REPORT ON MANAGEMENT OF CALCIFIED CANAL NON-SURGICALLY

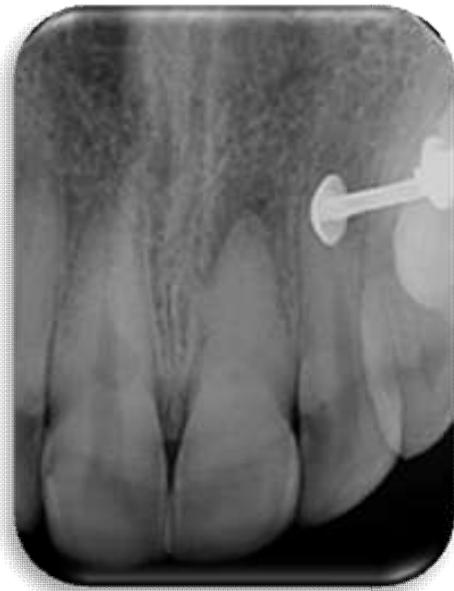
Figure 1. Radiograph showing no visible canal space in maxillary left central incisor

Preoperative radiograph revealed the presence of a single root with no visible root canal space in left maxillary central incisor compared other teeth (Figure 1.) Periodontal ligament space widening around the apical region was observed. Hence a provisional diagnosis of pulpal necrosis with apical periodontitis was made. Access cavity preparation was performed with access cavity preparation set (Dentsply-Maillefer). Initially no root canal orifice was found. Access was deepened by the munce discovery bur (Curtecy, CJM engineering) #1 and #2 for locating the canal orifice. Ultrasonic tips (BUC 1) were used to locate canal orifice. Then finally we found the access to the canal. The canal was negotiated using #6 and #8 K-file (Mani Inc, Japan). Working length was determined using electronic apex locator and confirmed radiographically (Figure 2) and then bio-mechanical preparation was done with K-File system (Mani Inc. , Japan). 5.2% sodium hypochlorite and 17% EDTA were used for irrigation. Tooth was obturated by using lateral condensation technique with AH Plus sealer (Dentsply) (Figure3,4).

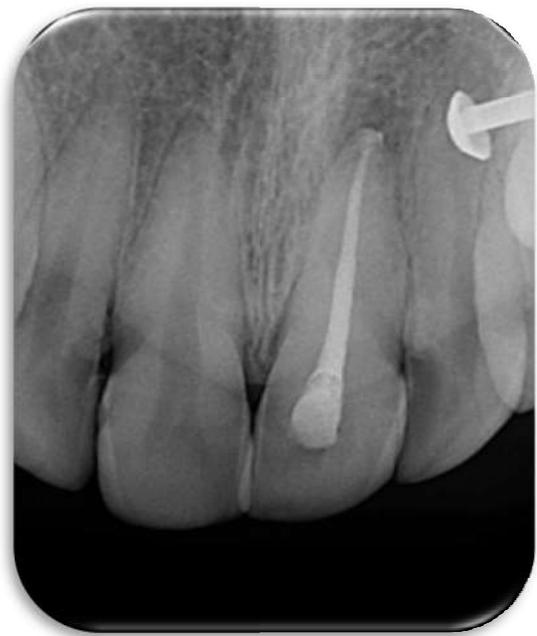
Figure 4. Post Obturation radiograph

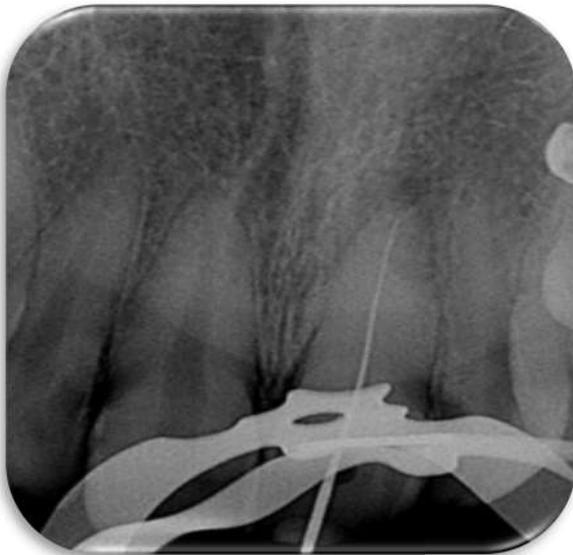
Figure 2. Working length determination

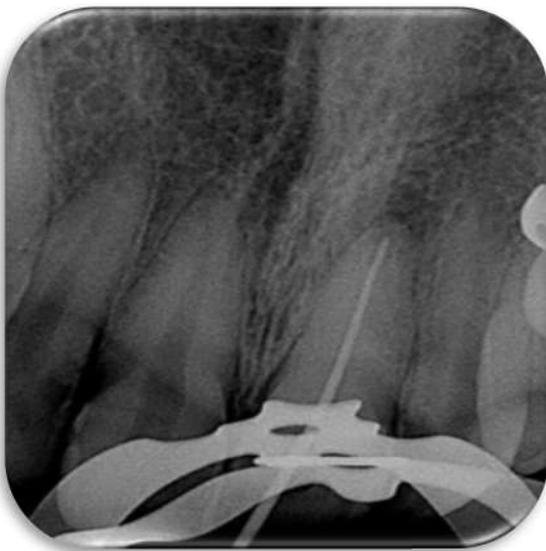
Figure 3. Master cone radiograph
